Components Cleaning Facility (CCF), East

Construction Completion and Operations, Maintenance, and Monitoring ADP

SWMU 030

September 2016

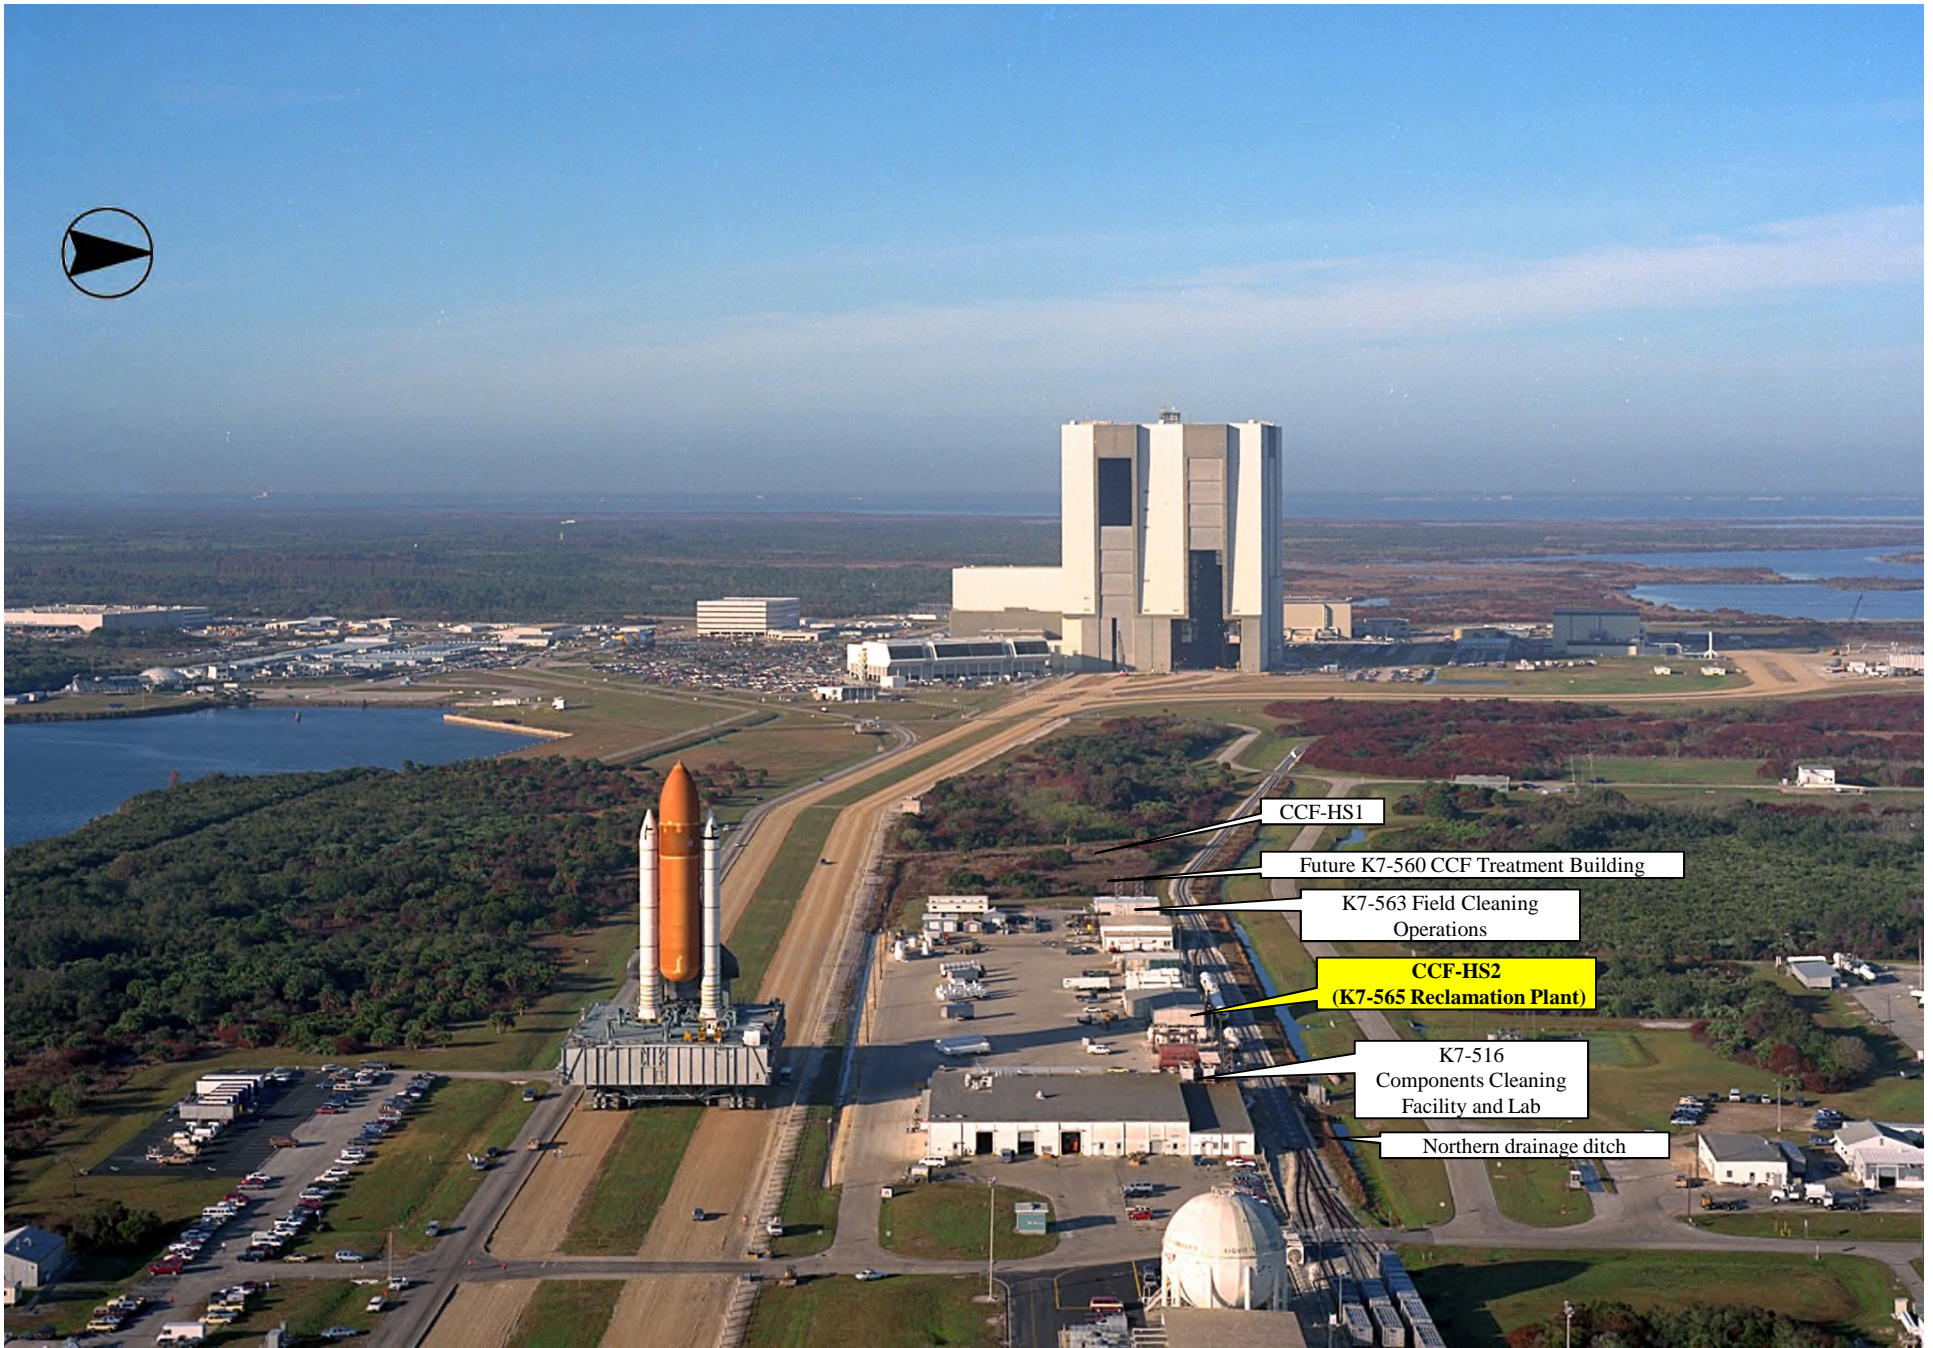
CCF-HS1

Future K7-560 CCF Treatment Building

K7-563 Field Cleaning
Operations

**CCF-HS2
(K7-565 Reclamation Plant)**

K7-516
Components Cleaning
Facility and Lab

Northern drainage ditch

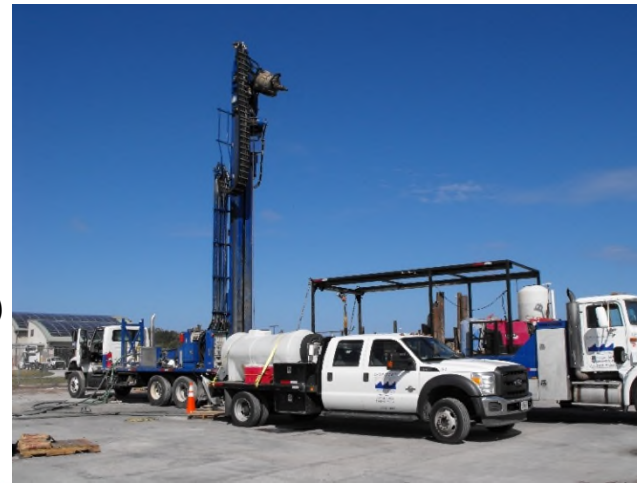
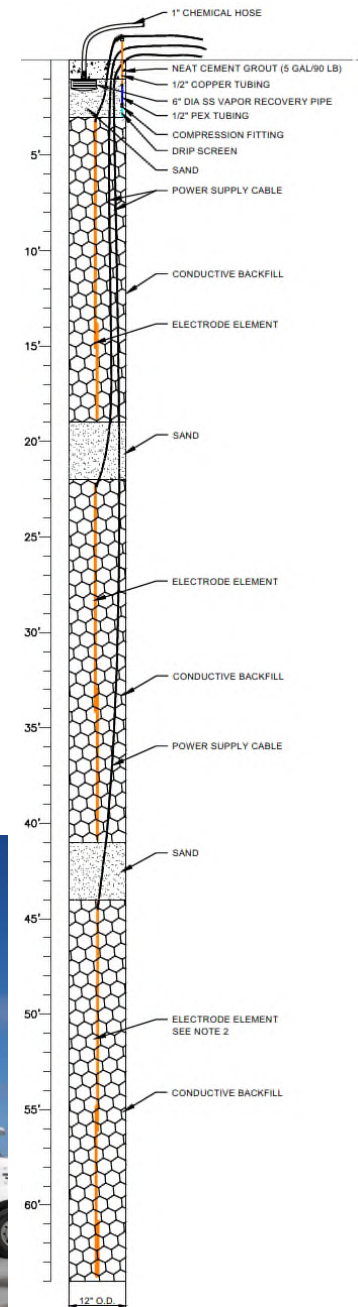
Electrode Installation

- 19 electrodes (12" sonic boring)
- Three elements per electrode (57 elements total)
 - Element 1: 3 to 19 feet bls (16-foot element)
 - Element 2: 22 to 41 feet bls (19-foot element)
 - Element 3: 44 to 64 feet bls (20-foot element)
- Elements installed in graphite and steel shot conductive material
- 3-foot fine sand layer installed between elements
- 6" diameter vapor extraction screens installed 1 feet bls
- Drip tubing screens placed at 3 feet bls
- One boring continuously cored
 - Conducted at electrode H4
 - Lithologic logging
 - PID screening
 - TOC samples collected (every 5')

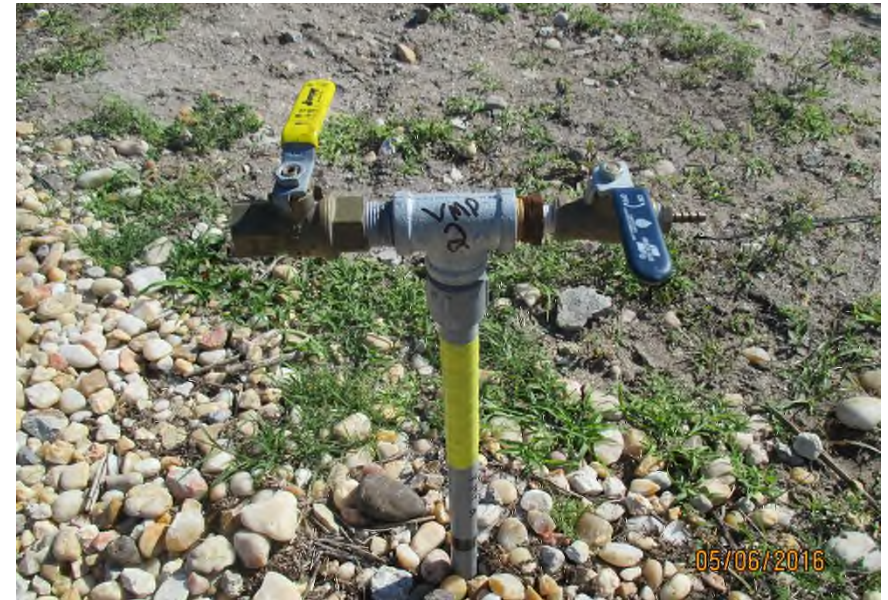
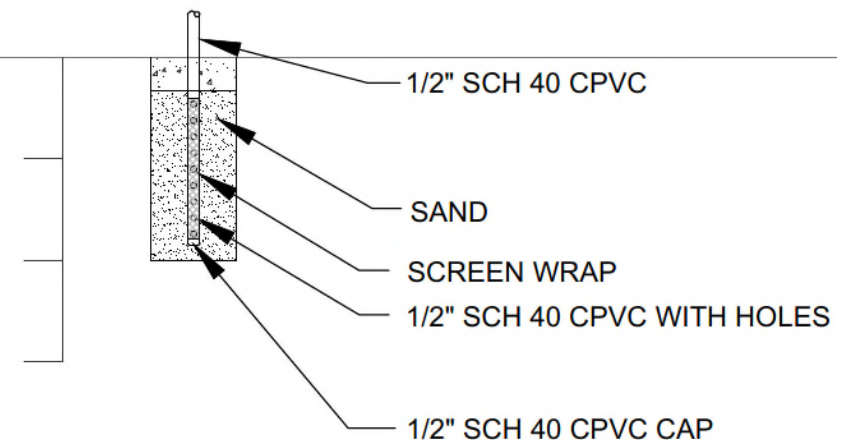
VMP Installation

- 8x vapor monitoring probes (VMPs)
- Installed along perimeter to monitor vacuum capture
- Vacuum readings measured with a magnehelic gauge

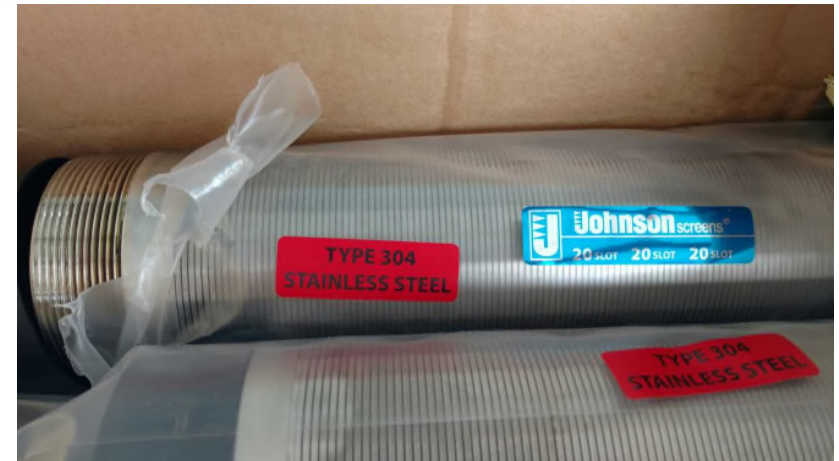
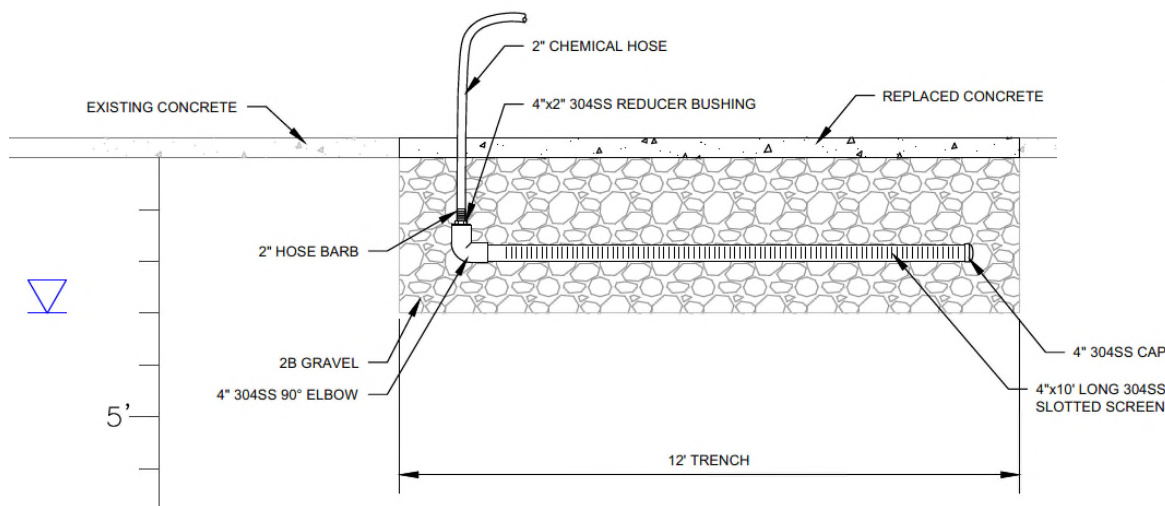
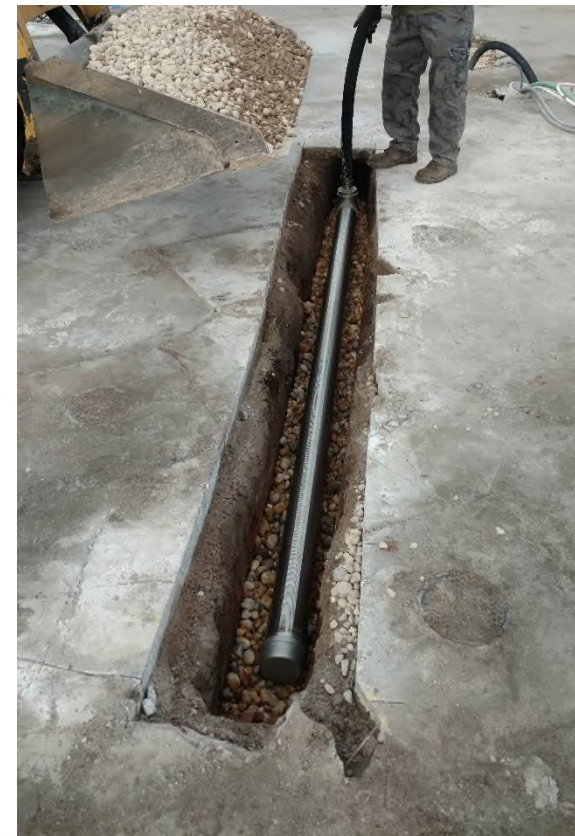
VE Installation

- 10x horizontal VE screens
- 10 ft long, 4 inch diam., 20 slot screens
- Installed to maximize vapor capture in treatment area with thin vadose zone
- Operated in addition to electrode VE points

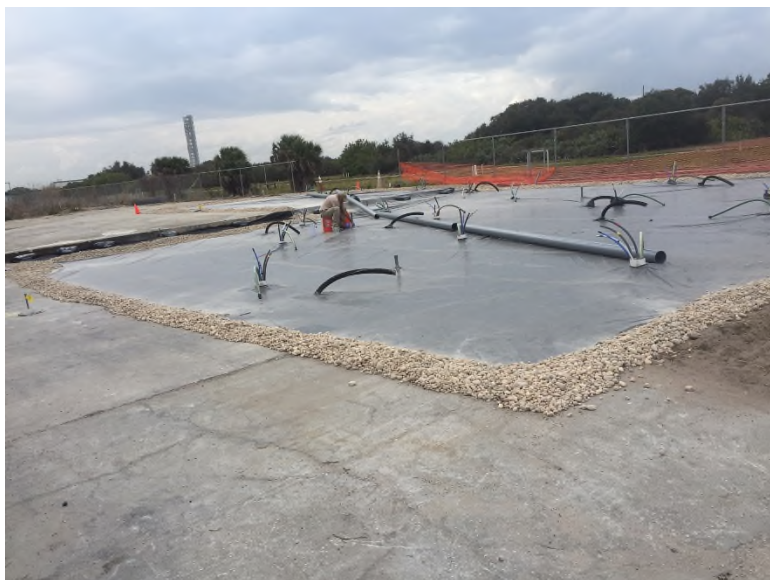
Electrode field prepped for cabling and piping.

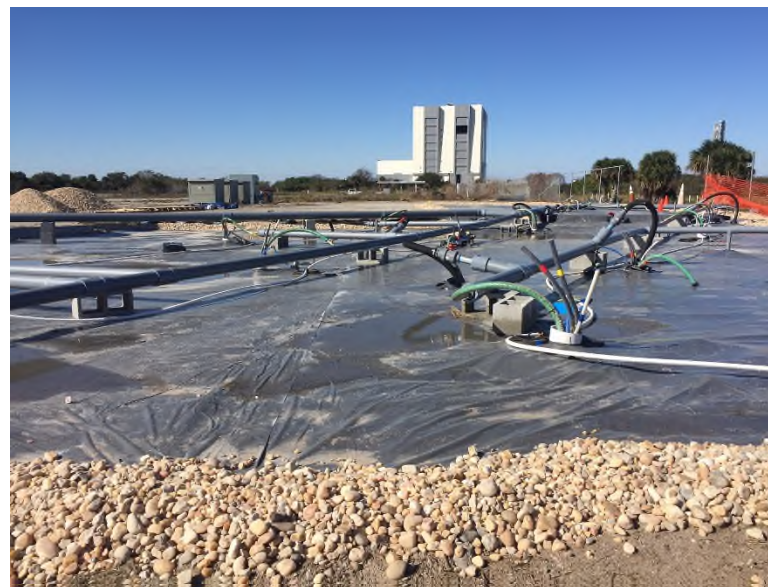
Installing VE piping and cabling.

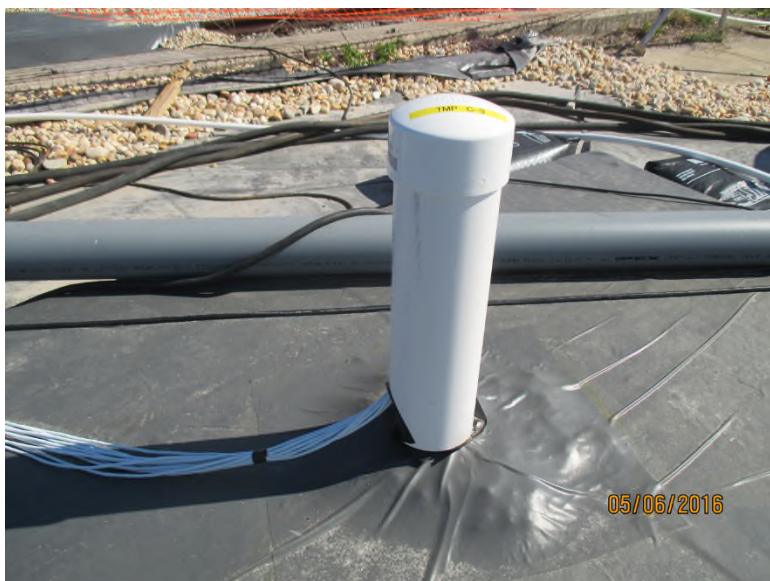
Temperature Monitoring Probe surface completion.

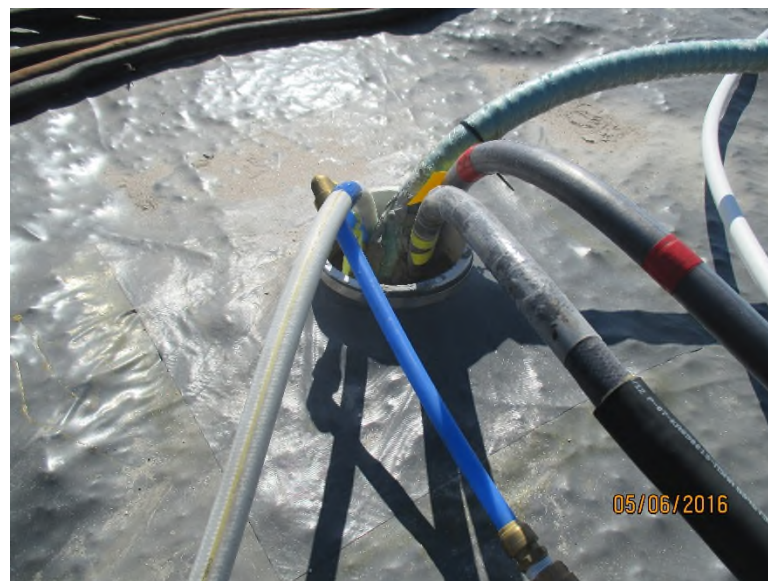
Electrode surface completion (3x cables, electrode drip, VE)

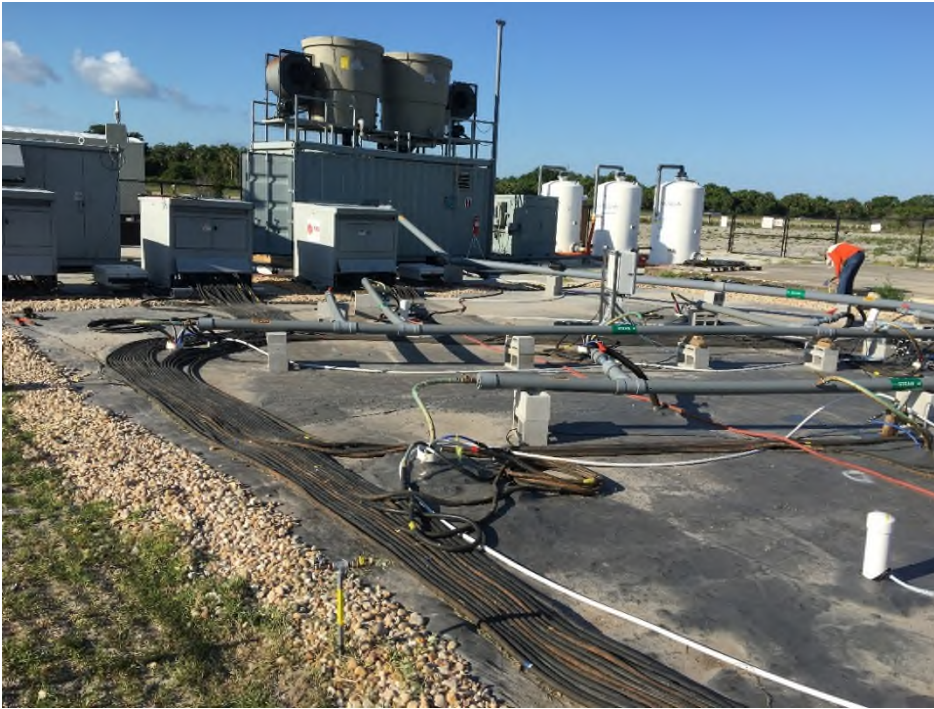
Completed electrode field (facing southwest).

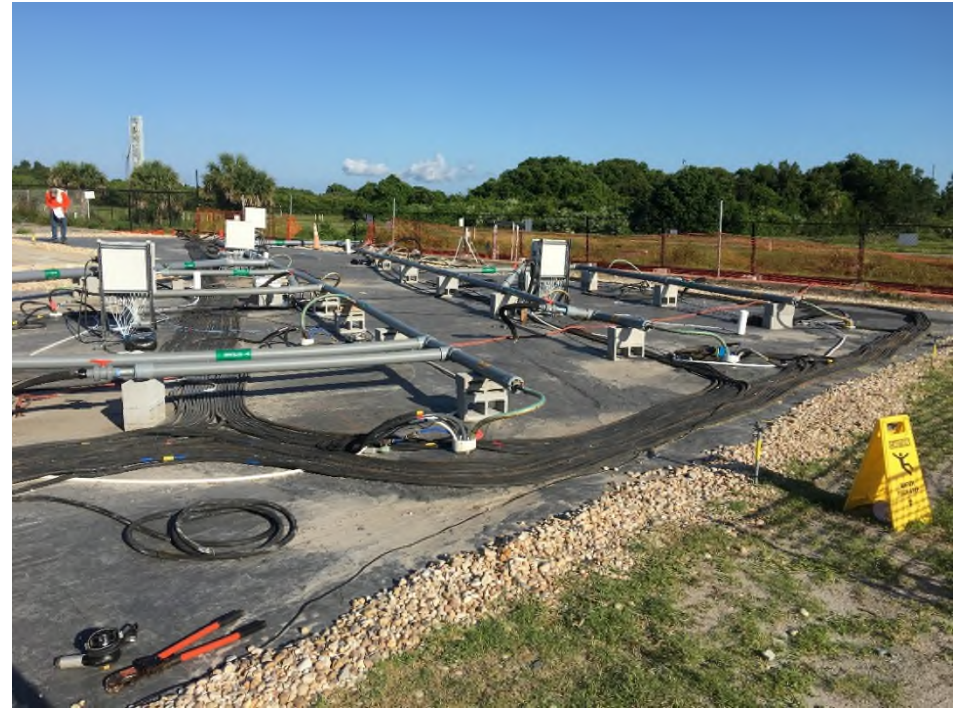
Completed electrode field (facing northwest).

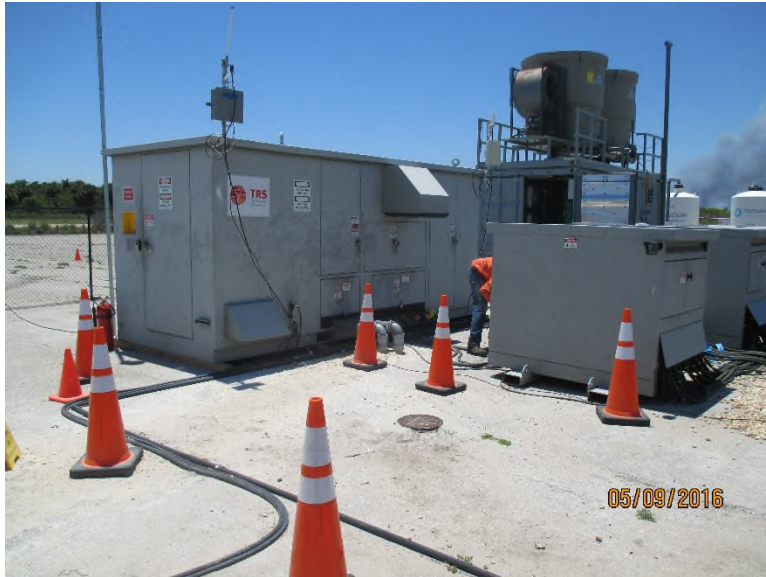
Power control unit and step down transformers.

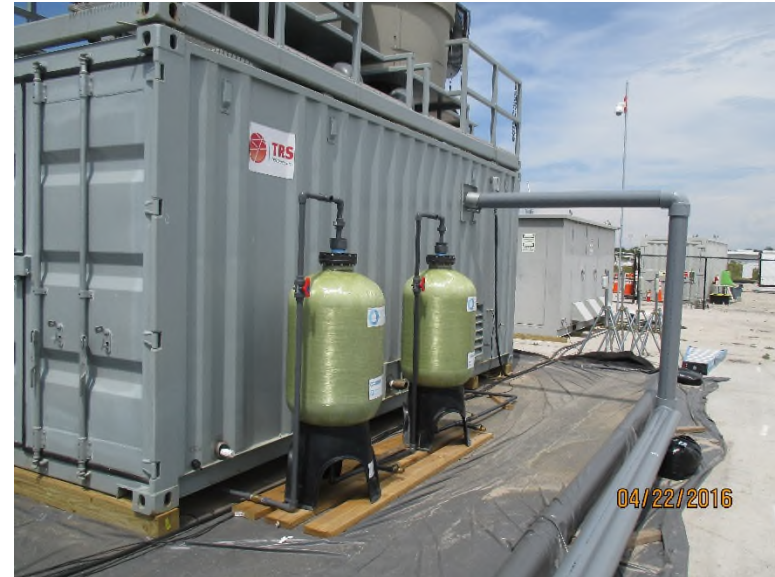
Condenser/cooling tower skid and liquid-phase GAC.

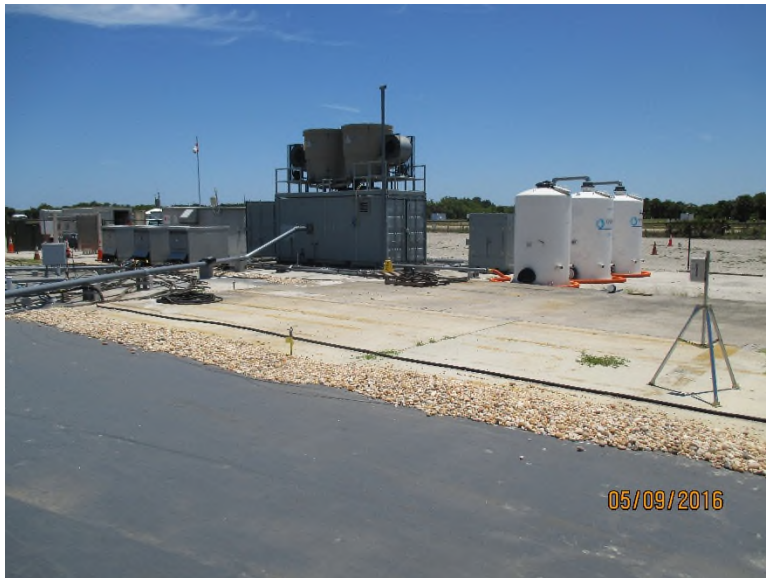
Cooling tower (middle) and vapor-phase GAC (right).

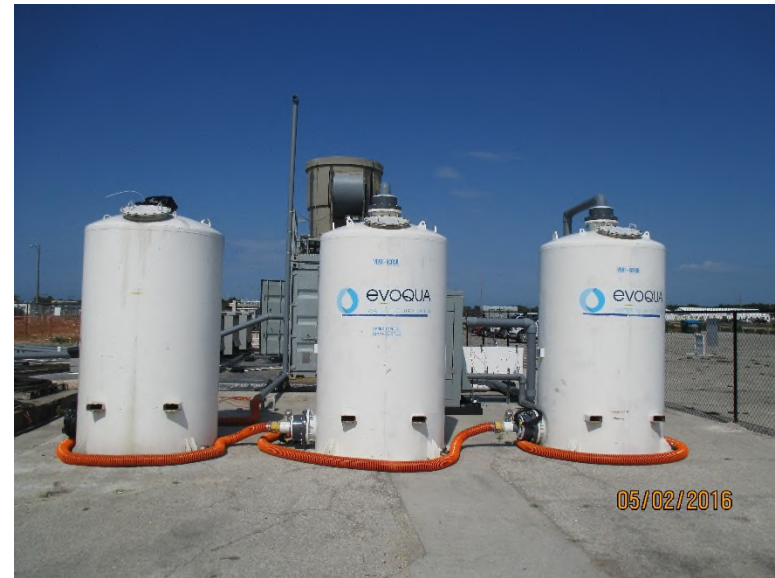
3x 3,000 lb vapor-phase GAC vessels.

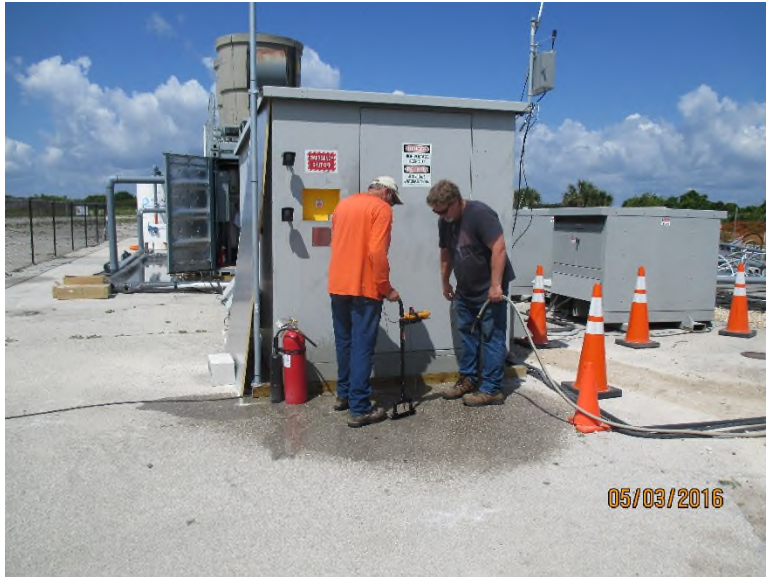
Surface voltage survey (at PCU entrance).

- Conducted to survey site for stray surface voltages
- Tested locations of potential receptor surface contact
- Conducted in voltage steps of 200V, 375V, 600V (max voltage)
 - Readings multiplied by voltage scaling factors based on step voltage
 - For example, 200V survey readings were multiplied by 3x
- Voltage survey thresholds (OSHA standard – 50V at surface):
 - 5V in unrestricted area (outside ERH perimeter fence)
 - 10V in restricted area (in ERH perimeter fence)

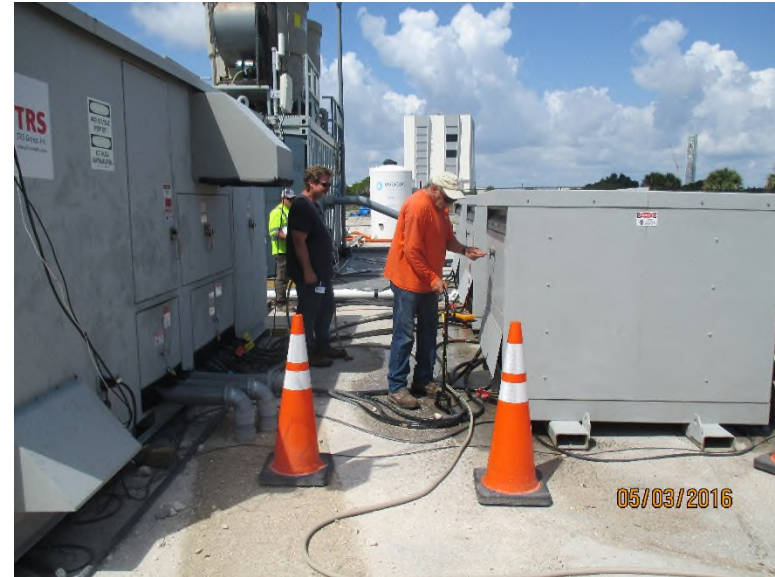
Surface voltage survey (at step-down transformers).

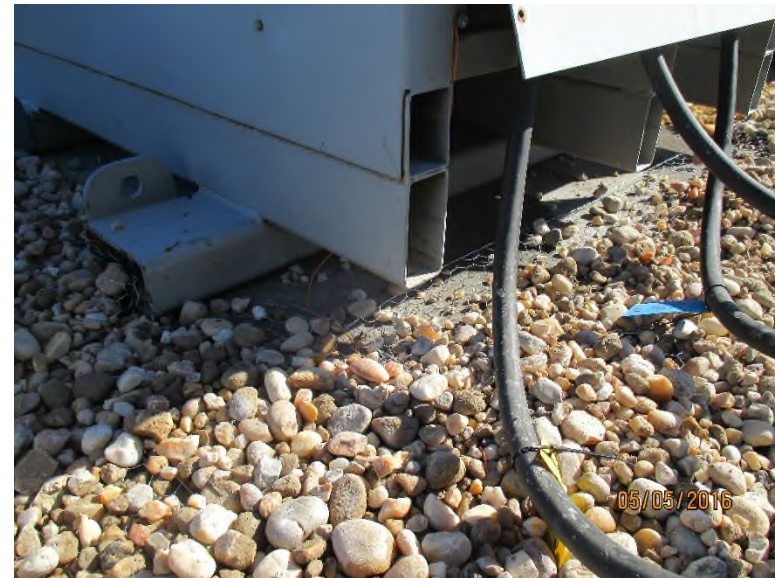
Surface voltages identified above thresholds at:

Surface voltage mitigation at western step-down transformer.

- Existing fenceline to the west of ERH perimeter fence
 - Mitigation: remove top rail, over-sleeve with PVC, coat vertical rail brackets with insulating surface cover
- Western-most ERH step-down transformer
 - Mitigation: install voltage isolation mat bonded to transformer
- Hose bib for potable water service connection
 - Mitigation: Coat metallic parts with insulating surface cover
- Stainless steel valve and piping from former operations
 - Mitigation: Piping excavated and removed sub-grade
- Following mitigation, surface voltage re-measured and confirmed below thresholds

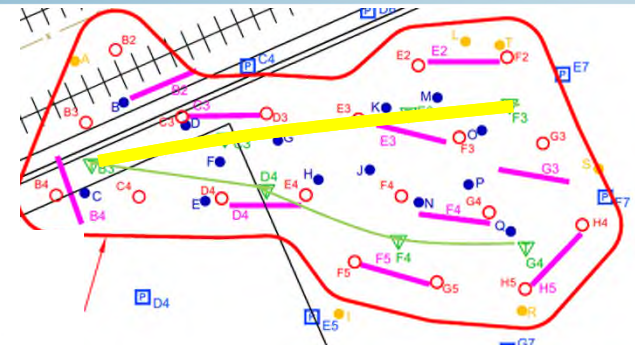
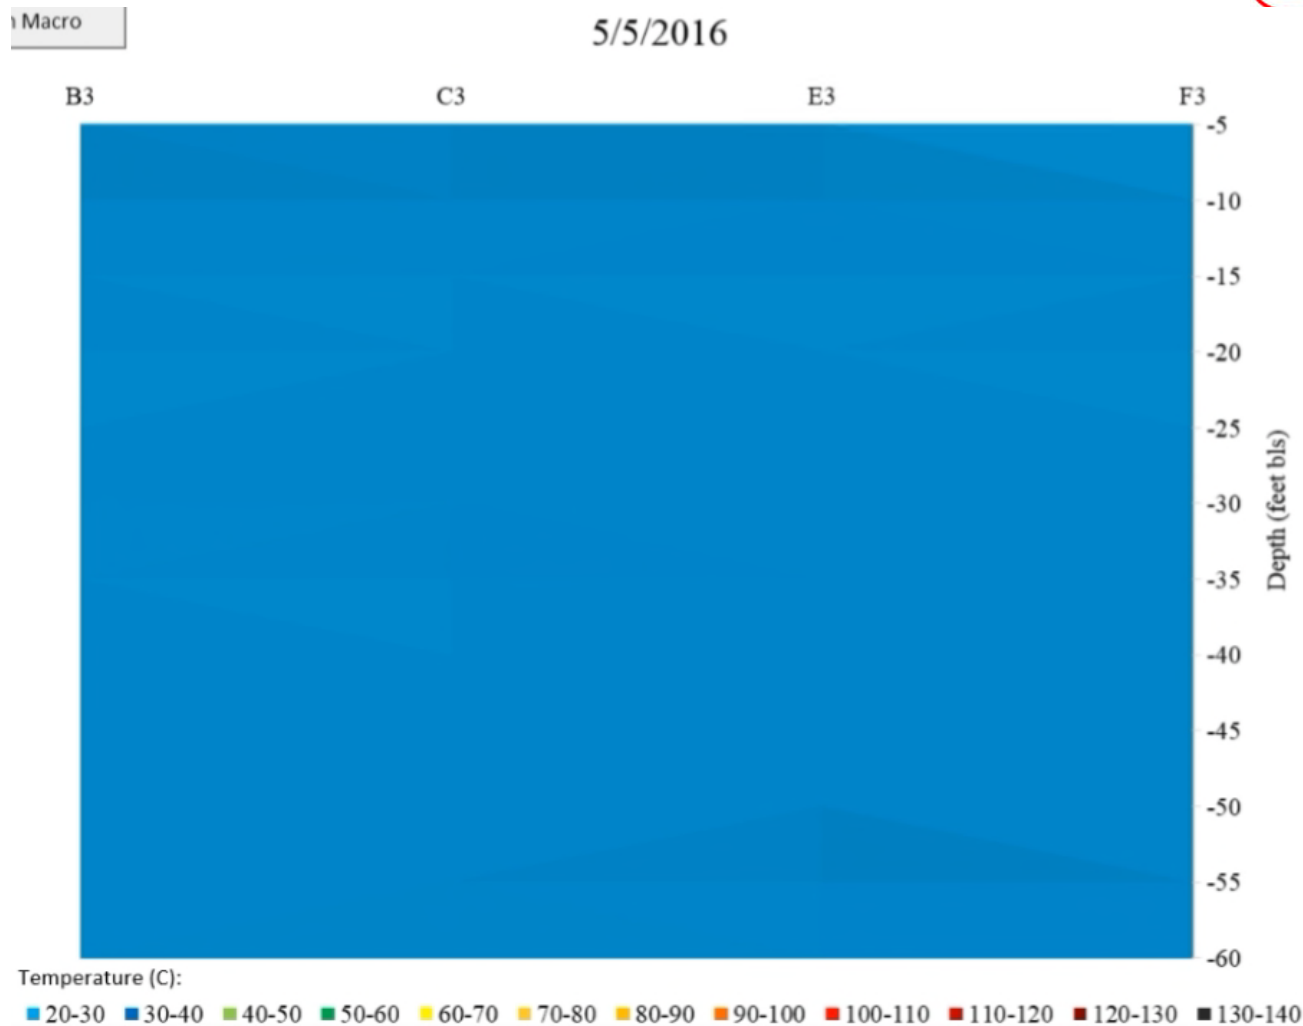
Temperature Monitoring Data

Note: Horizontal TMP distances not scaled.

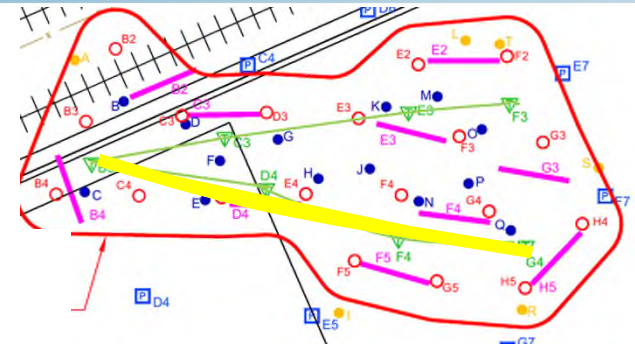
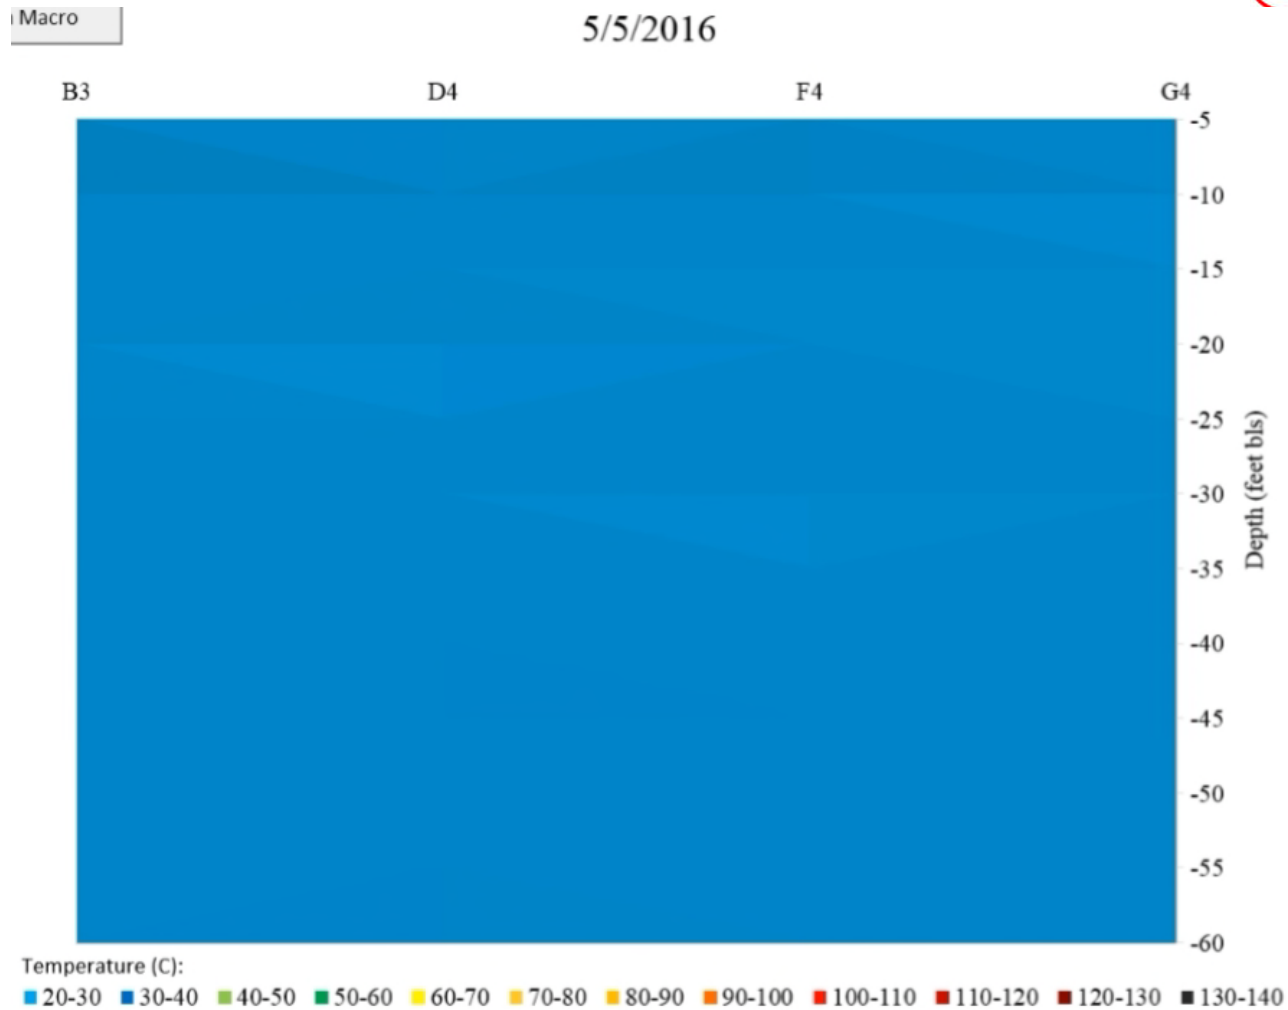
Temperature Monitoring Data

Note: Horizontal TMP distances not scaled.
